OPERATIONAL EVALUATION OF NEMO,

AN ACRYLIC-HULLED SUBMERSIBLE

Technical Report R-778

P. K. Rockwell and H. J. Migliore

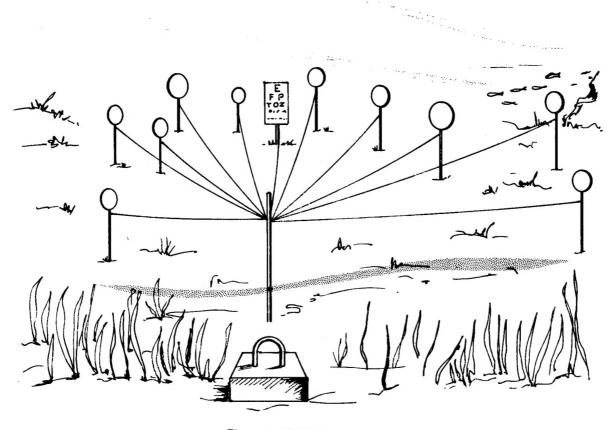
Figure 2. Visibility array.

An experiment was designed by the Naval Personnel and Training Research Laboratory (NPTRL) to determine empirical relationships between perceived and actual size and distance of circular targets. Ten circular targets fixed to stakes were driven into the sediment in 50 feet of water near Anacapa Island (Figure 2). A large iron clump was placed at the focal point of the array and NEMO's anchor cable was attached to the clump. This provided a known reference point to which NEMO could descend repeatedly to standardize the data taken during the experiment. Subjects were instructed to estimate the size of the discs, the distance between NEMO and the discs, and to read an eye chart placed at the center of the array. The subjects ranged from experienced NEMO operators who also had scuba diving experience, to neophytes who had never been underwater, either in a submersible or by diving. The significant results of this study are:

- 1. The experimental results corresponded well with the theory of Reference 8; that is, subjects tended to underestimate both size and distance.
- 2. The experience level resulted in significantly different estimations. Experienced NEMO operators estimated accurately the size and distance, whereas subjects who had never been underwater significantly underestimated size and distance.
- 3. All subjects agreed that the shapes of objects and underwater life appeared to be normal.

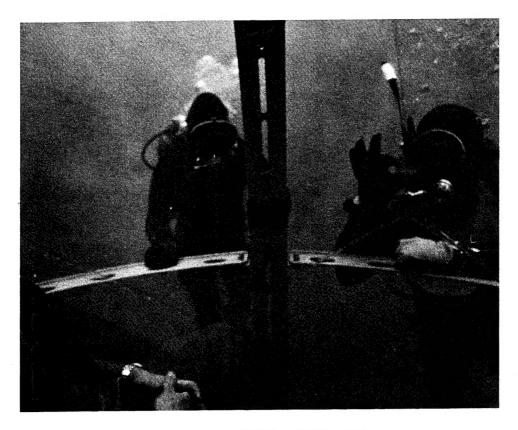
Design Configuration. Since the primary purpose of using an acrylic hull is to provide excellent viewing, the NEMO system was designed to present a maximum unobstructed view to its occupants (Figure 1). The lower unit, which consists of the service module, battery, ballast tanks, and winch system, is smaller in diameter than the hull. The operator can easily see the bottom as he approaches it. The only obstruction to viewing is the structural cage assembly. These members are slender and positioned so that the operator has a 120-degree unobstructed field of vision directly in front of him. Equally important, the section joints do not significantly affect the view (Figure 3).

Figure 3. View from NEMO at 40-foot depth.

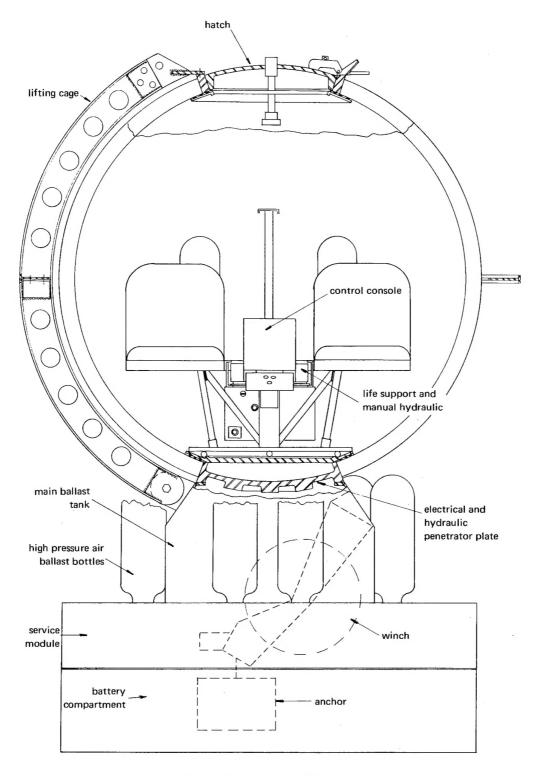
Figure 4. Schematic of NEMO system.

Seating. The most frequent complaint regarding conventional submersibles is that the observer must assume uncomfortable positions to use the viewports. In NEMO, the seating position of the operator and observer (Figure 4) is very comfortable. The personnel can see up, down, and to the sides with a simple head motion, and rotation of NEMO provides viewing in all directions. Even though the seat location is not in the exact center of the sphere, occupants can look through the hull at any angle without experiencing distortion. The erect seating position is ideal for data taking, and the seat design is comfortable for long-duration dives. The only objection to the interior arrangement is the lack of storage space. This drawback does not significantly reduce the comfort of the crew but does cause inconvenience and wasted time in gaining access to some items.

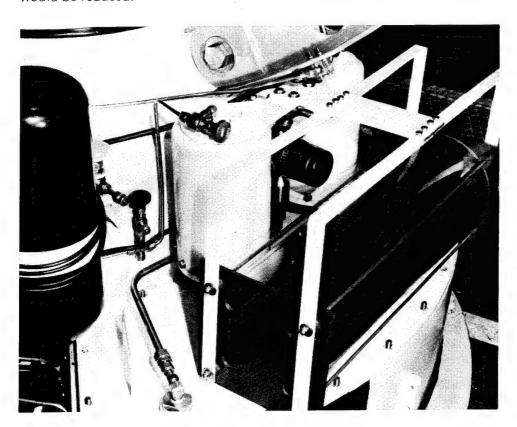
During the builder's trials in the Bahamas and at Anacapa Island, one acrylic battery cover cracked. The battery compensator, which is a rolleddiaphragm piston-type compensator, was suspect. The pressure differential needed to move the compensator piston was measured to determine whether the compensator was working correctly. It was found that a 1-psi differential was needed to compensate, but a 3- to 4-psi differential was needed to reset the compensator. Since the battery pack is equipped with 1.5-psi pop-off valves to allow hydrogen gas expulsion, mineral oil was escaping through the pop-off valves instead of resetting the compensator. The compensator was disassembled, serviced, reassembled, and retested. The operational differential pressures were both about 1 psi, but the reset time for the compensator was about 10 seconds. During the January cruise, NEMO was winched to the surface in 5-foot increments with 30-second stops every 5 feet to determine whether the compensator would reset. The compensator did not reset, and apparently was deficient in two ways: (1) The compensator volume (about 1 gallon) was inadequate to compensate for oil compression, gassing, and trapped air in the battery pack. (The design of the battery pack does not allow expulsion of all trapped air before a dive.) (2) The reaction time was

so slow that pressure built up in the pack on ascent, causing oil to escape through the relief valves instead of resetting the compensator. A 5-gallon bladder-type compensator system (Figure 5) has replaced the original compensator. This change has eliminated the compensation problem.

Figure 5. Compensator and ABT (auxiliary ballast tank) flood valve.

Recommendation. The existing battery pack covers are flat plates of acrylic plastic with a domed region leading to the battery pack vent lines. In theory, all the gas in the battery pack should migrate to those domed regions and be vented out. In practice, however, gas pockets remain at other regions under the flat plates and are never vented. This problem can be eliminated by replacing the present cover with a sloping surface design, where the high point would connect with the vent line. This design would ensure that all entrapped gasses are eliminated both before and during a dive. Thus, the compensator would only have to make up for fluid compression, there would be less fluid lost during ascent, and the possibility of hydrogen gas buildup would be reduced.

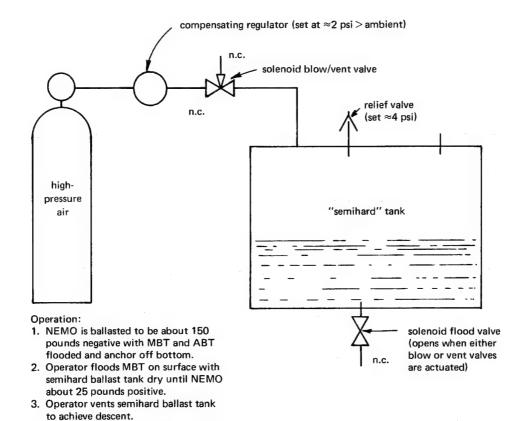
Recommendation. The NEMO ballast tanks cannot be easily controlled in shallow water since both tanks are open to seawater. This phenomenon can be controlled by the operator at deeper depths, since the rate of air expansion is much slower than at shallow depths. The modification of NEMO's auxiliary ballast tank from an "open" to a "semihard" or pressurecompensated ballast tank would effectively eliminate this control problem. A semihard ballast tank (Figure 6) is an ambient-pressure ballast tank, closed to seawater by valves, with an automatic control system (regulator and relief valve) which maintains a constant volume of air in the tank even though NEMO changes depth. The regulator/relief valve system senses change in ambient pressure, and lets in water or adds air as needed to maintain constant air volume. In other words, once the operator has put the correct amount of air in the ballast tank to achieve neutral buoyancy, the buoyancy does not change with depth unless the operator changes it. The addition of a semihard ballast tank should make neutral buoyancy easier to achieve, resulting in increased safety, greater translation ability, less ballast air consumption, and fewer operator-controlled changes.

Figure 6. Schematic of semihard ballast tank.

4. Operator controls descent by regulating water volume in semihard ballast tank.
 5. Pressure regulator feeds gas into semihard ballast tank as NEMO descends

Relief valve vents gas from semihard ballast tank during ascent to prevent
